Rattlesnake Gutter Trust Monitoring - CR Form

1. Property Name: Cheyette CR

Year: 2024

2. Date of Monitoring: 12/05/2024

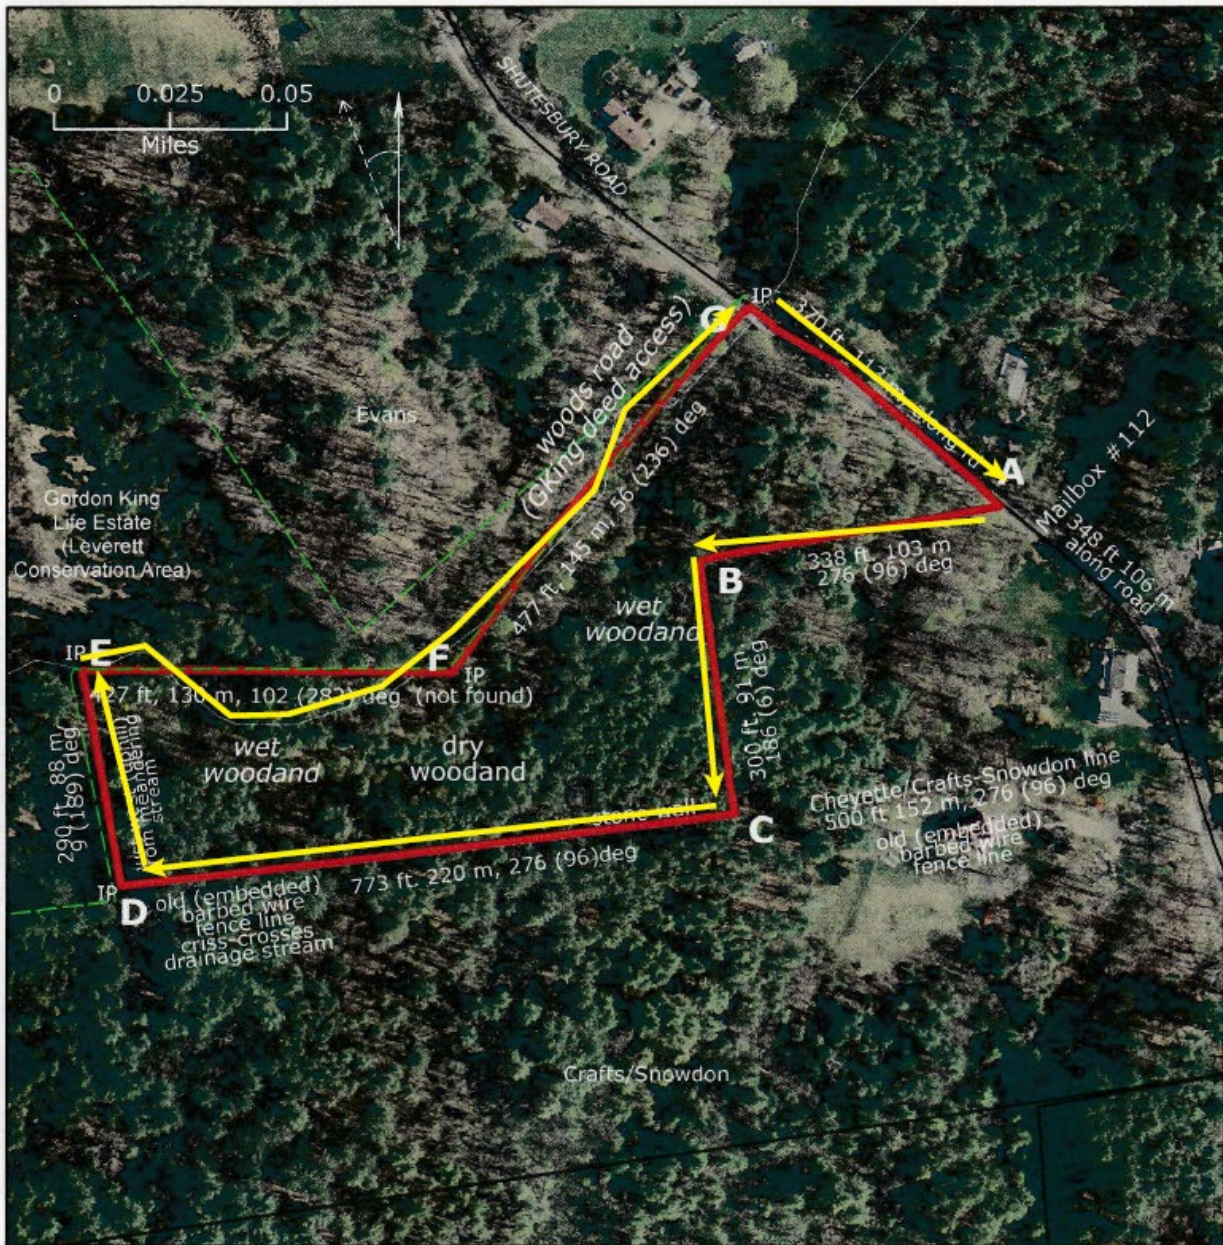
Cheyette CR Map for Monitoring

- A. SE corner of CR (road, near house). 42.44495041, -72.48550504. orange rebar
- B. Inside corner of building envelope) 42.44473080, -72.48666652 2, orange rebar
- C. SE corner of CR (behind house, on line) 42.44404399, -72.48651540, orange rebar
- D. SW corner of CR (abutting G.King) 42.44382782, -72.48917607, iron pipe by tree trunk
- E. NW corner of CR (east of covered bridge) 42.44453349, -72.48926609, iron pipe
- F. Along stream, 42.44450734, -72.48771535 (not found, ribbon on tree no longer obvious)
- G. NE corner of CR (road, at stream) 42.44555927, -72.48656552, culvert, bent metal (orange pipe n side of stream

Note: all found iron pipes have 3-dot orange paint on trees, Most lines painted orange (NO PAINT along roadside, streamside, or along stone wall section of s.side).
