Property: Cheyette Conservation Restriction	Year of this Report: 2012
Owner: name, address, phone, email if relevant (Also name of local contact if relevant.):	
<p>Frederic Cheyette Address: 119 Shutesbury Road, Leverett, MA 01054 Telephone: 413-548-9023 Email: flcheyette@amherst.edu</p>	
Date owner invited to monitoring: about an hour before the visit (voice mail) then met him before and after my walk.	
Date and recommendations from last year's monitoring:	
<p>Plan for time to walk/paint with the owner.</p>	
Date of this year's monitoring: October 25, 2012	
Participants: Mary Alice Wilson	
Brief description of route taken (also draw on map):	
<p>Started at A, walked counterclockwise to G and then on around and back to A. I did not check for ribbon on tree at F.</p> <p>Multiple tracks on the map after covered bridge represent first a walk to hang ribbons and find the next corner stake, then walking back to the previous stake painting the trees, then removing ribbons on final trip to the end of the section. (On the south line, the walk was from the corner to the beginning of the stone wall. The barbed wire embedded in the trees comes out of the center of the tree, those pines must h

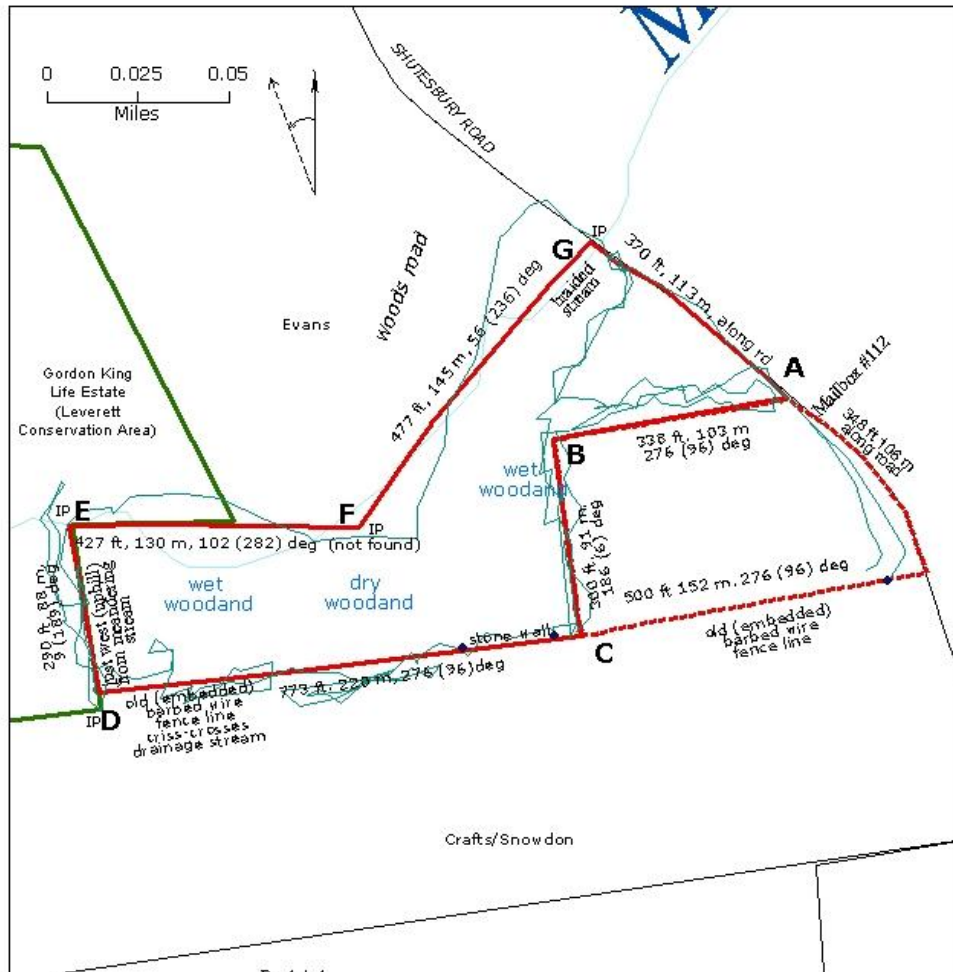
- A. SE corner of CR (road, near house). 42.44495041, -72.48550504. red rebar
- B. Inside corner of building envelope) 42.44473080, -72.48666652 2, red rebar
- C. SE corner of CR (behind house, on line) 42.44404399, -72.48651540, red rebar
- D. SW corner of CR (abutting G.King) 42.44382782, -72.48917607, iron pipe by tree trunk
- E. NW corner of CR (east of covered bridge) 42.44453349, -72.48926609, iron pipe
- F. Along stream, 42.44450734, -72.48771535 (not found but ribbon on tree approximate)
- G. NE corner of CR (road, at stream) 42.44555927, -72.48656552, culvert, bent metal (red paint) pipe n side of stream

Note: all found iron pipes have 3-dot red paint on trees, Most lines painted red (not roadside, streamside, not along stone wall section of s.side).
