## **Rattlesnake Gutter Trust Monitoring Report**

Property/Conservation Restriction Name: Cheyette Conservation Restriction

Date of visit(s): November 20, 2011 CR? Yes Owned by RGT?\_\_\_\_\_

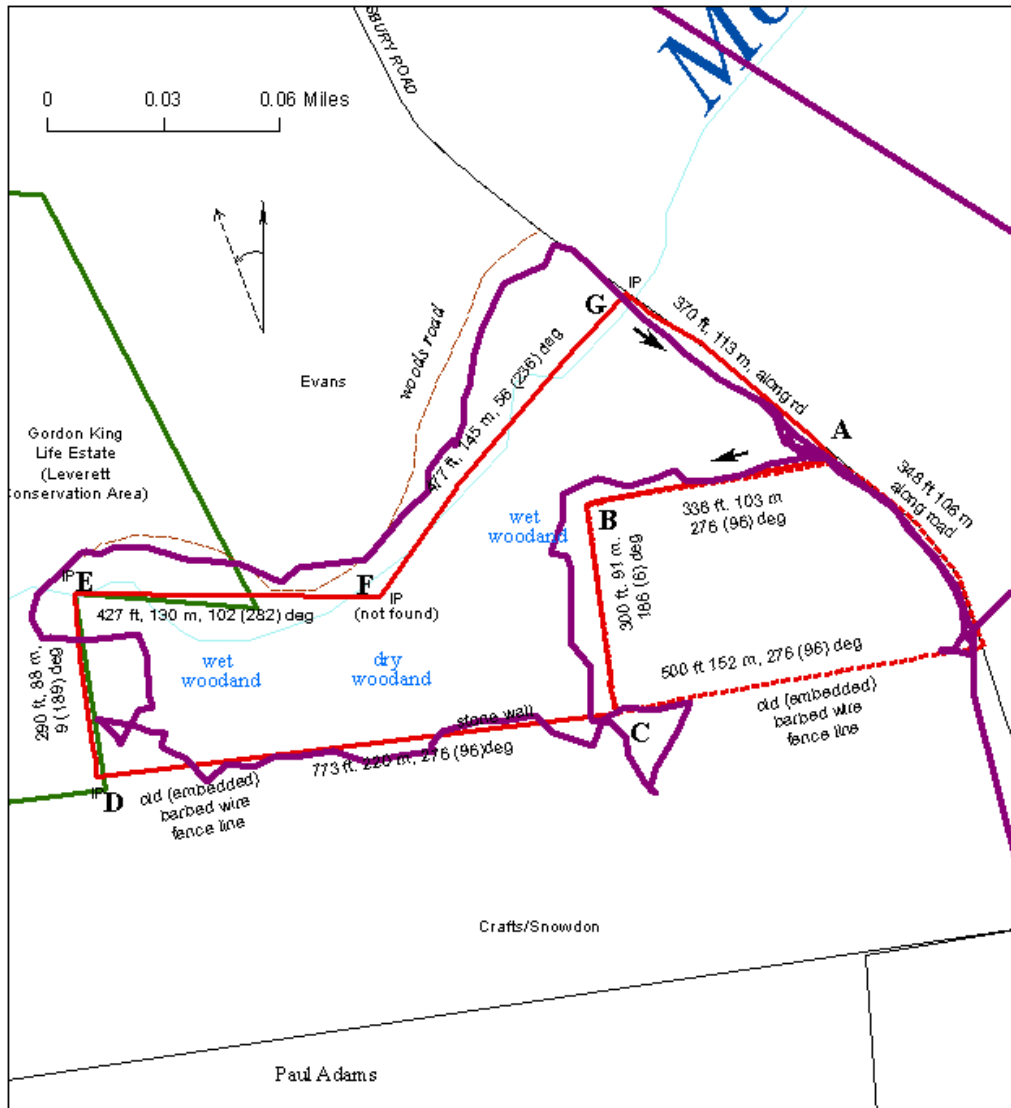
# Cheyette CR for Monitoring

As the track of the monitoring shows, we managed to lose our way in the SW corner. Reminding us once again that the lines should be painted. Next year.

(Map was also inadequate, latitude, longitude and description have been added.)

Just the painting of the line
