Ellamoose Repose for Monitoring

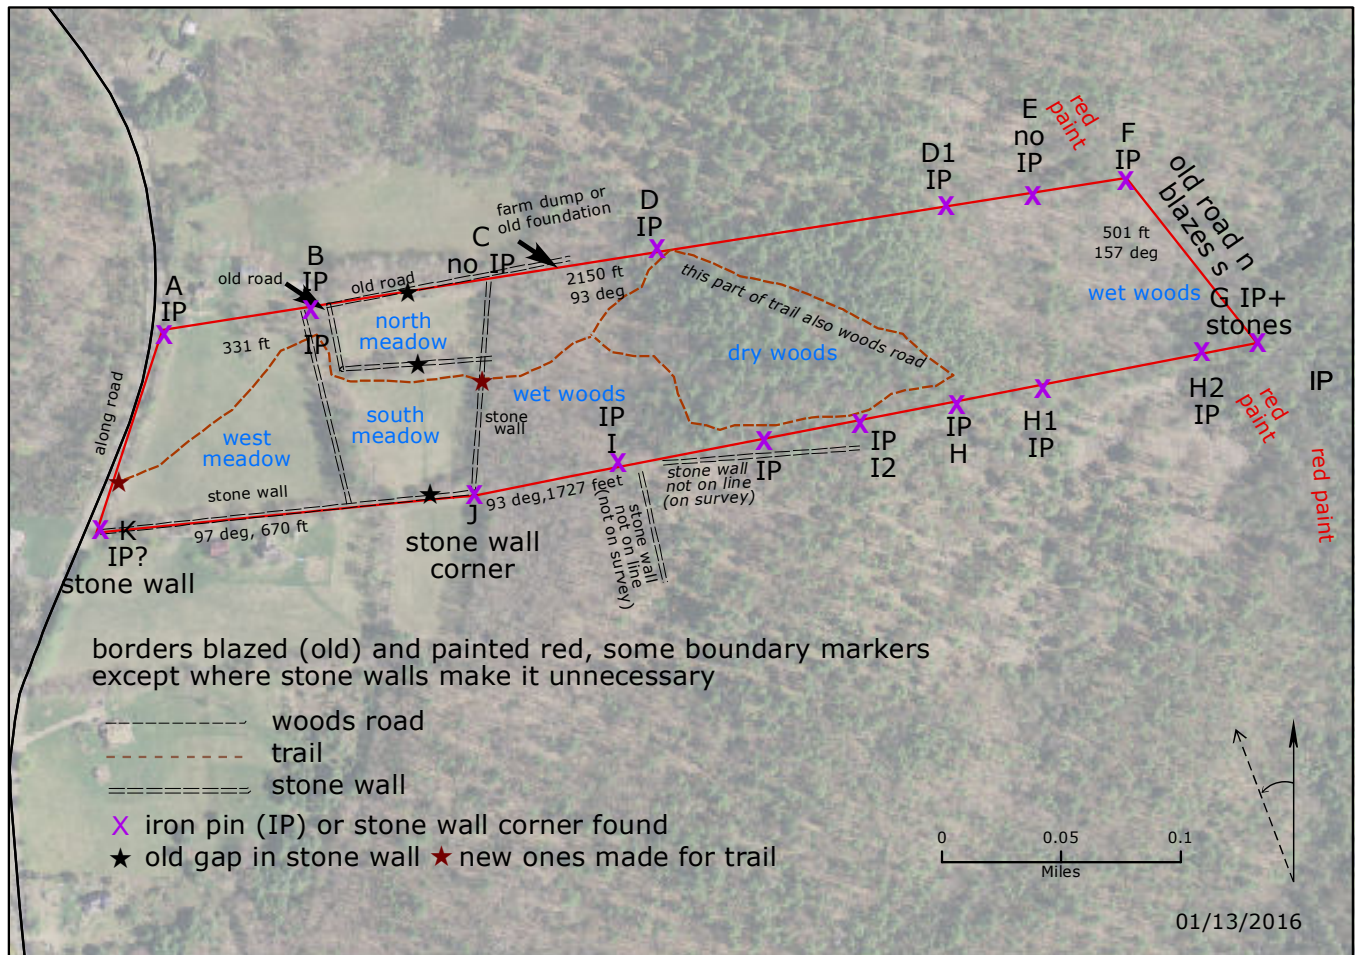
- A. NW corner on road at edge of stone wall, iron stake, 42.49396, -72.49554
- B. N edge, iron pipe, 42.49409, -72.494299
(this first section of line does not follow land use or stone walls, stone wall begins here, line easier to follow to the east). There is an road visible between two stone walls.

- C. End of meadow, near stone wall which does not follow line. Boundary line painted on old blazes.
- D. Trees blazed to ne corner, stone wall ends here 42.49450, -72.491443

- D1. Lot to north heavily logged/thinned, 42.494818, -72.489092
- E. pin on survey, did not find
- F. Pin, northeast corner, beyond logging, 49.494968, -72.487613, east line blazed (old) and painted (old and new). Line going north also blazed red.

- G. Southeast corner, large iron pipe/stones, 42.493944, -72.486624, east line is blazed. Line going south is also painted red (confusing)
- H2. On flat land can see G through the trees. 42.493903, -72.486979

- H1. On slope 42.493655, -72.48829
- H. Pin just west of trail/woods road, 42.493557, -72.489013.
- I2. Very short pin at south edge of trail, about 10 feet inside blazed line 42.493461, -72.48979 line up with E end of large stone wall off property

- I1. mid stone wall 42.49335, -72.490609
- I. West of off-site E-W and N-S stone walls., 42.493216, -72.491778
- J. Beginning of stone wall on line, 42.49299, -72.492942. wall continues on line to road

- K. Southwest corner, stone wall corner at road, 42.49274, -72.496029
