Property: Gibavic Family Conservation Restriction	Year of this Report: 2013
Owner: name, address, phone, email if relevant (Also name of local contact if relevant.): ( <i>skip if owned</i> ) Eva Gibavic, 10 Rattlesnake Gutter Rd, Leverett, MA 01054, 413- 548-9451 Donald Gibavic, 20 Cave Hill Road, Leverett, MA, 01054, 413-548-9322 Anne Gibavic, PO Box 74, Sutton, VT 05867 Paul Gibavic, 3 Sunderland Rd, Montague, MA 01351	
Date owner invited to monitoring ( <i>skip if owned</i> ) August 2, 2013	
Date and recommendations from last year's monitoring: 1. Paint the lines. 2. Follow-up on the vernal pool certification. 3. Try to figure out NW corner 4. After dry weather, motorcycle should be removed	
Date of this year's monitoring: August 2, 2013 (Mary Alice returned to north line on August 28)	
Participants: Mary Alice Wilson (RGT); Eva Gibavic (Gibavic Family)	
Brief description of route taken (also draw on map):  Counter clockwise from Eva's house. We did not visit the SW corner and walked in the meadow rather than along the very full stream.

Photographs of NW corner

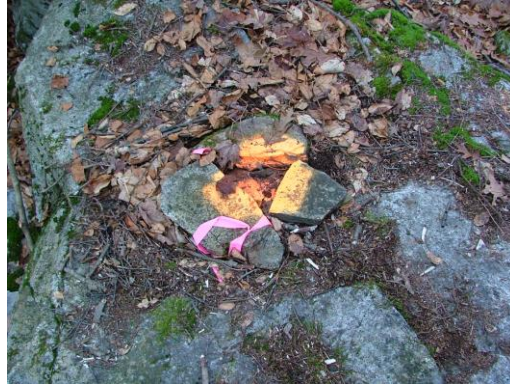
Northwest corner, drill hole  
(from baseline report)

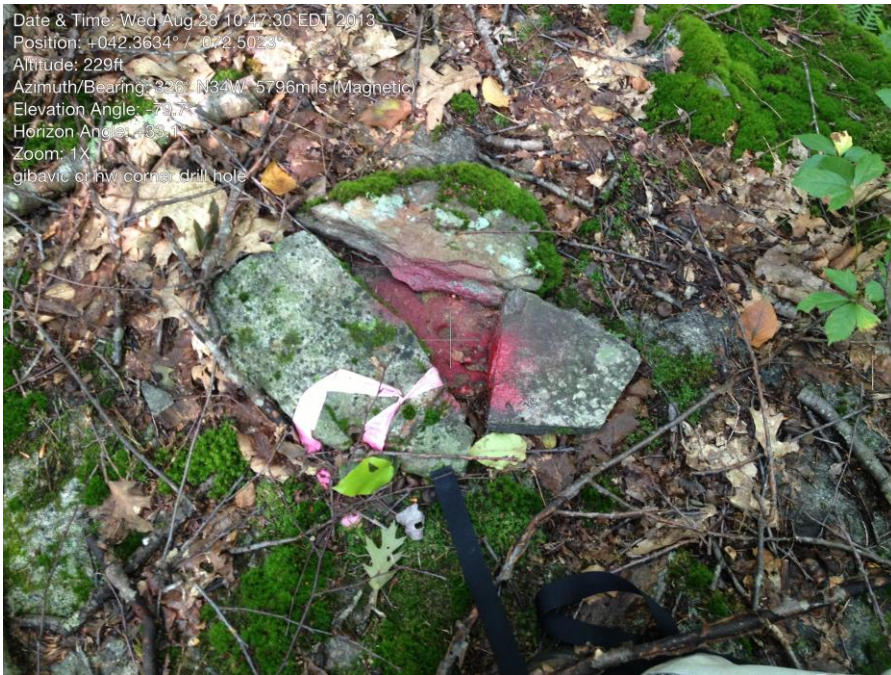
Same drill hole (ribbon has faded)

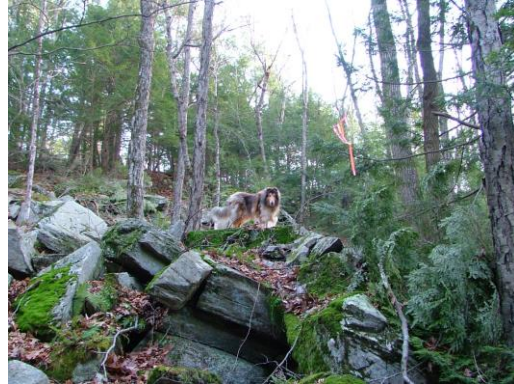
12/3/2006  
NW corner, drill hole  
looking back to cliff with view  
(family dog standing on drill hole)

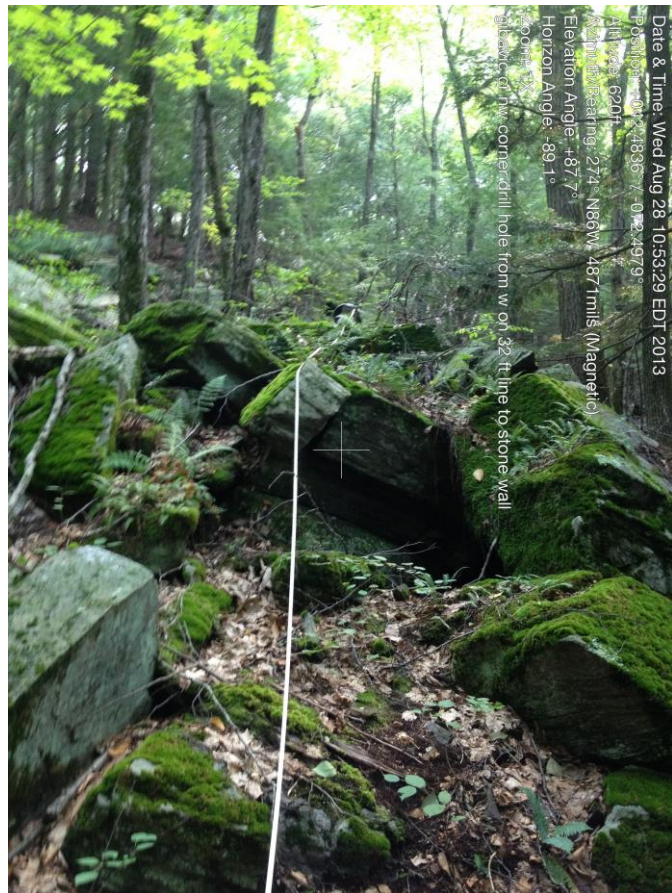
Survey does not include the iron pipe which is on the north line fairly near the iron pipe labeled "D" on the monitoring map. Nor does it mention the drill hole. The lead pin in the boulder in the stone wall was not found, but that stone wall is 32 feet from the drill hole (see photographs).

same view - backpack at the drill hole  
white tape measuring from drill  
hole to stone wall behind the  
photographer (32 feet)  
August 28, 2013  
(moss has spread in 7 years)

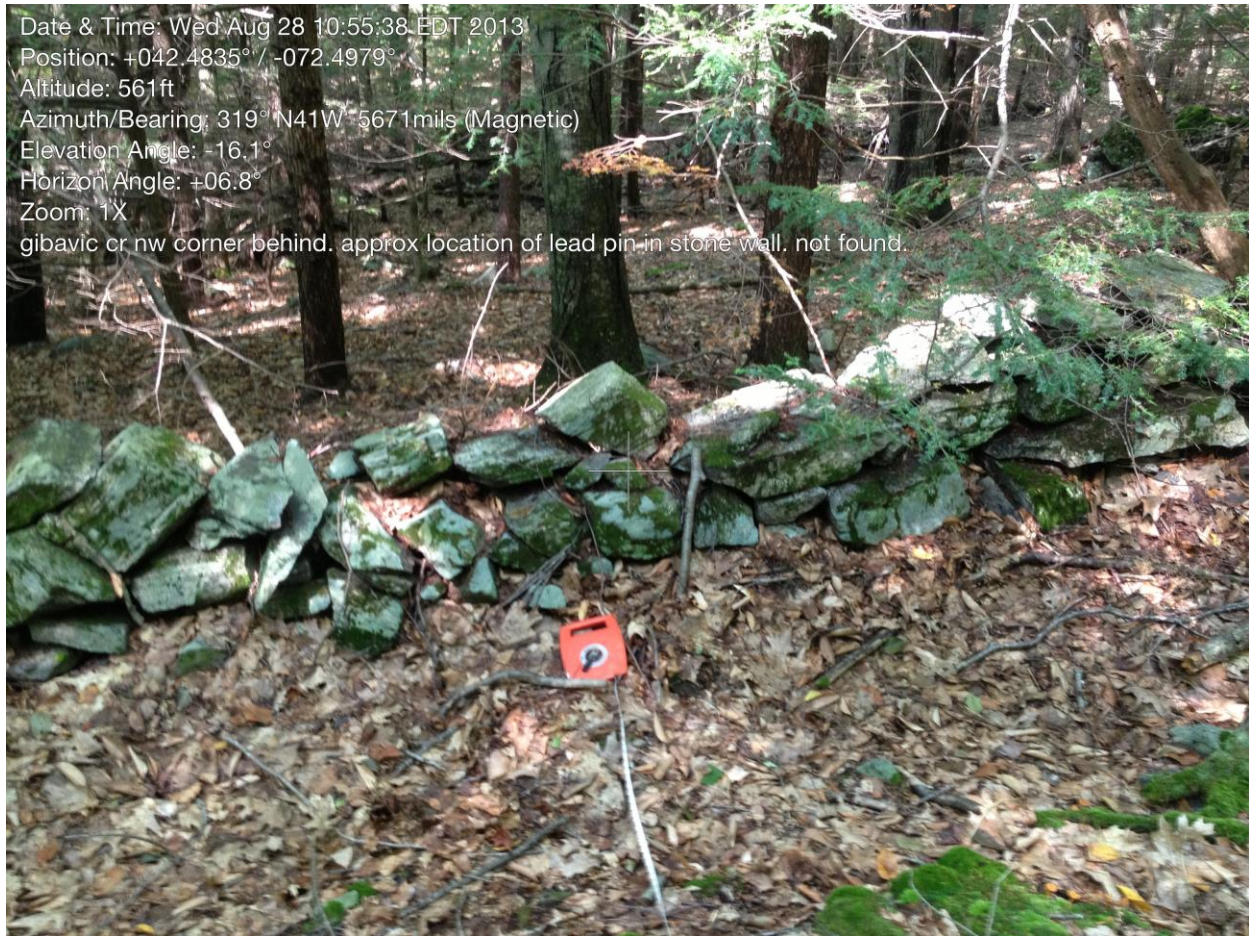
View of the stone wall on the neighboring property (32 feet beyond the NW Corner of the Gibavic Family Conservation Restriction). A lead pin is in one of these stones (mentioned in the survey). Photograph taken at the same place as the previous view up to the drill hole (NW corner) August 28, 2013.
