Property: Gibavic Family Conservation Restriction Year of this Report: 2012
Owner: name, address, phone, email if relevant (Also name of local contact if relevant.): Eva Gibavic, 10 Rattlesnake Gutter Rd, Leverett, MA 01054, 413- 548-9451 Donald Gibavic, 20 Cave Hill Road, Leverett, MA, 01054, 413-548-9322 Ann Gibavic, PO Box 74, Sutton, VT 05867 Paul Gibavic, 3 Sunderland Rd, Montague, MA 01351
Date owner invited to monitoring (<i>skip if owned</i>) Monitoring was planned so that Eva Gibavic could participate.
Date and recommendations from last year's monitoring: 11/20/2011 1. paint fading boundaries 2. review pins/corners (C-F) in NW area, confirm gps readings and correct map 3. look for stone wall corner pin (I) 4. look for illusive "meadow pin" (J)
Date of this year's monitoring: October 14, 2012
Participants: Mary Alice Wilson (for RGT), Eva Gibavic (for Gibavic family)
Brief description of route taken (also draw on map): See green track on map. We went counterclockwise from Eva's land to Old Cave Hill Road. Red circles are location of waypoints taken to confirm readings taken last year (B1, C, D, E, F) or to confirm readings from previous years. (I, J) Changes were made in th

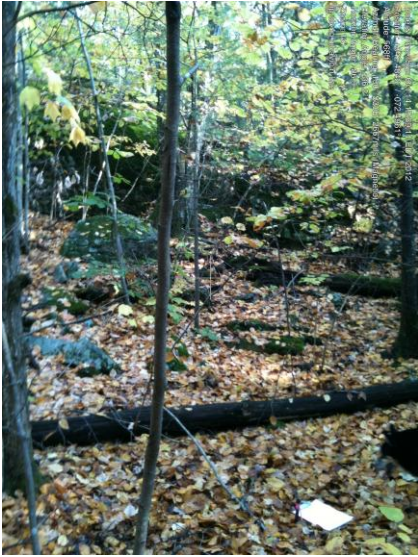
We re-found an iron pin along the north line (now labeled B1, see picture).

B1. Iron pin on north line (about mid-way)

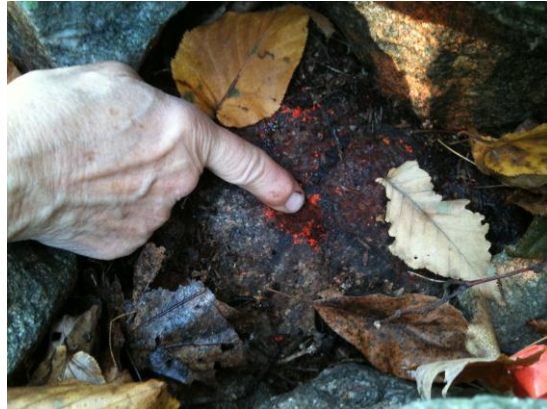
We were able to confirm the location of two of the western points (E and F on the map). The monitoring map line is now changed to reflect those points. One (F) is not an IP but a drill hole! (see picture)

F. Drill hole (along western line)

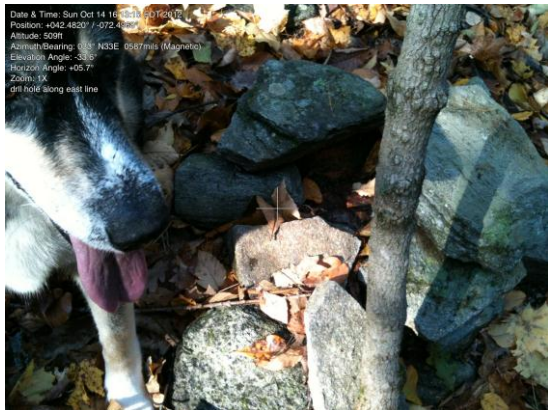
F. Drill hole (and Sadie)

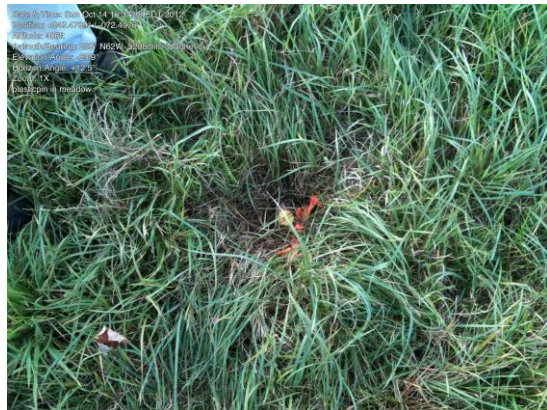
And, surprisingly, found the surface-level yellow plastic pin in the meadow. In fact, it is possible to approximate its location by aligning the flowering tree on the road and the large (middle) maple along the stone wall bordering the Gibavic/Howland property. The pin for that corner is half way between the maple and a large white quartz rock in the wall to the left of the tree. It is right against the stone wall (picture).

J. Meadow corner (yellow plastic post)

K. IP (yellow top) between white quartz stone and maple tree.
