Property: La	urel Hill Comr	non Lands
--------------	----------------	-----------

Year of this Report: 2013

Date of this year's monitoring: October 15, October 17, and October 23, 2013

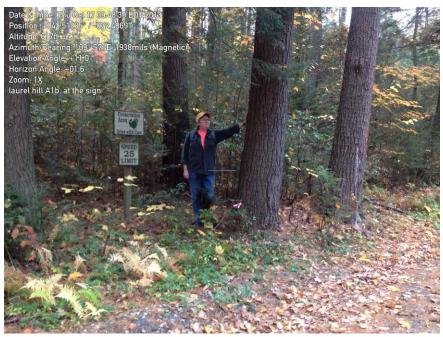
A1 Approximate location.

Using this as the SW corner of Common Land A, the survey angles seem to come out right at the SE corner. Metal detector did not find post.

3-dot corner marking painted on back of tree.

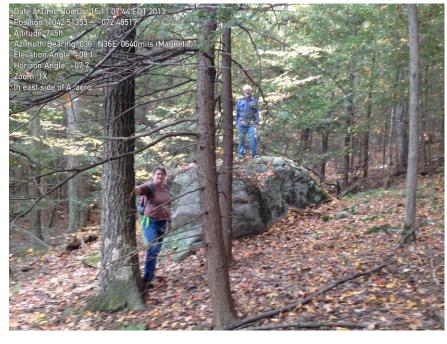
A2. Survey says "unmarked corner" but a huge stone serves as well. Mary at tree, Richard on the huge stone.

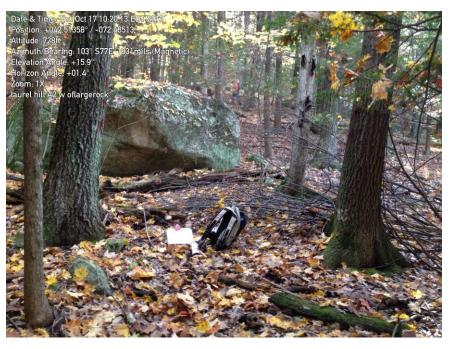
A2. coming from the other direction (east). Again huge rock serves as the center corner.

The approximate line between Common Land A and Lot 1 was painted. Should the need arise, a surveyor would need to locate the theoretical IPs at the road corners.

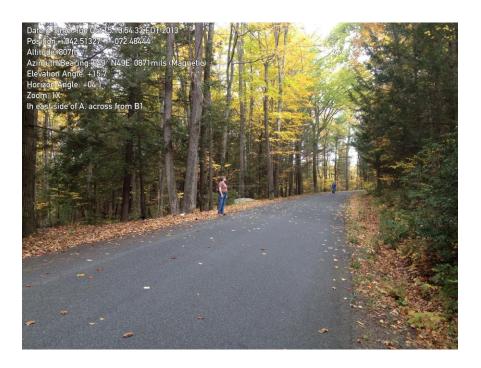
## A3.

Mary standing across from B1, i.e. SE corner of Common Land A.

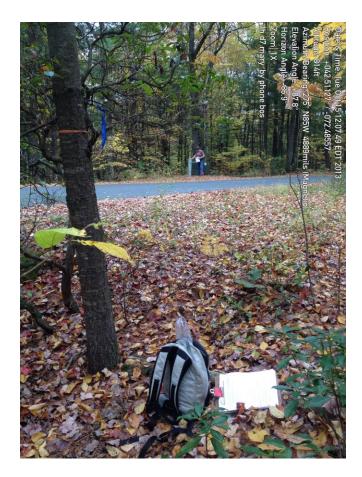
D. D7 correct on the map, flagging on the former corner (before the new septic system) was removed to avoid confusion

D7. Corner post well back in the woods. Mary across the road at telephone distribution box.

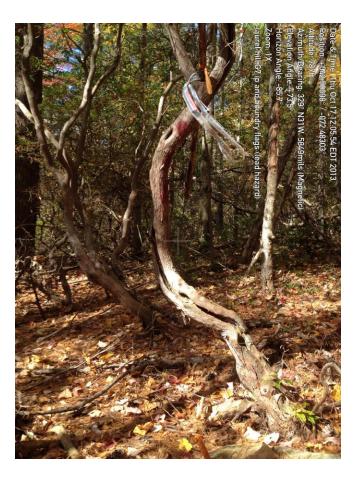
Along the G8-G9 line, brush from clearing on the neighboring property has been pushed onto the Common Land. While it is only brush and not an environmental hazard, it will be important to talk with the future owner to make sure the line, an appropriate behavior, is understood.

Repainted the G8-G9 and part way to G10 (to the edge of the neighboring property). The owners of the property marked the north edge with rather disconcerting "caution lead removal" ribbon - presumably left over from some other project. The G8-G9 line has the debris from the clearing (presumably for the driveway) over the line/stone wall. (When the property is sold, meet with the owner to make sure the line, and appropriate behavior is understood.)

G8. Markings along line with property to the south (caution/lead recycle flagging) done presumably by owner to the south.

2. When the property east of G8-G9 is sold, meet with the owner to clarify line (and discourage dumping across the line.)

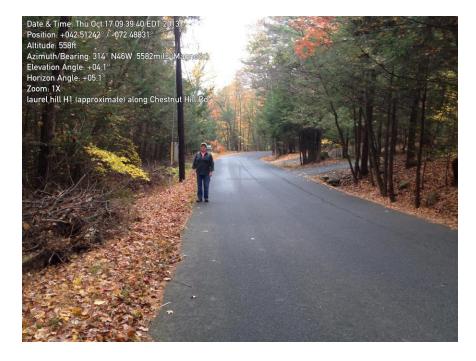
H. South corner along Chestnut Hill Road was measured from the town line (and measurement re-check in ArcMap. While no pin could be found in the rubble along the road, both the survey and the deed for the neighboring lot (Ian Winokur) indicate that there is an iron pipe. The metal detector was no help. The approximate corner was painted for future reference.

H1. Approximate location of southern corner of Common Land H. Debris makes searching for pipe difficult (nor did metal detector locate it.)

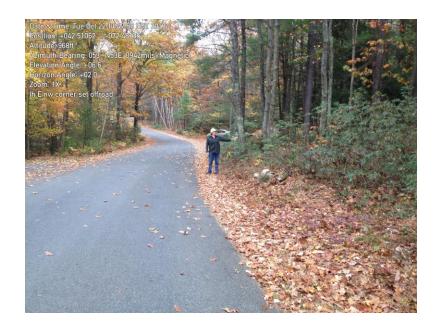
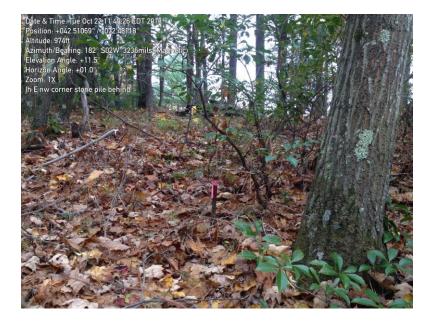
E1. NW corner along the road. (The NE corner, E2, is farther along the road at the next turn.

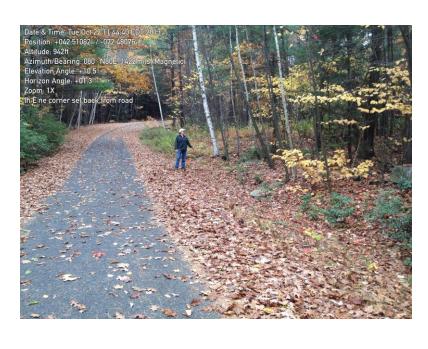
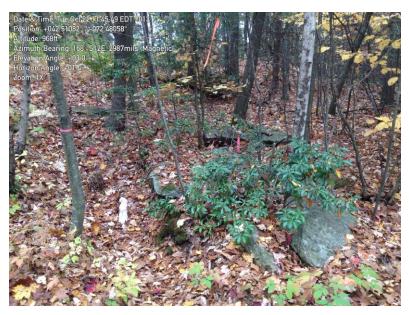
E2. NE corner along the road

E2. Close up

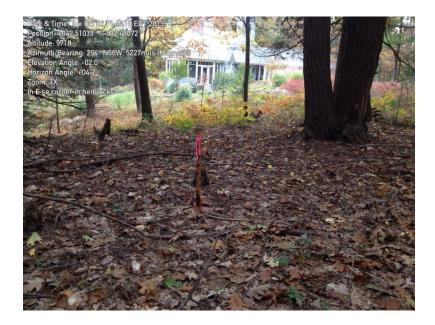
E3. Northeast cornerin open woodland.Looking back toward the house.(E4 at the left side of the photo)

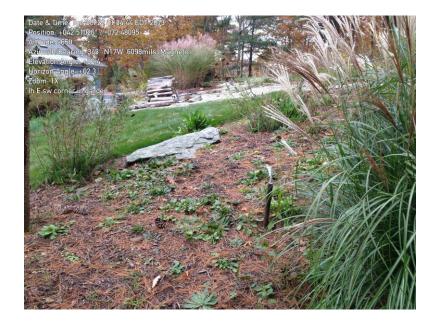
E4. Southeast corner in landscaped area

looking toward the house

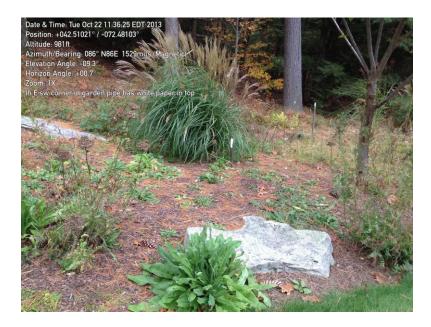
E4. Same corner looking east toward E2.
