RGT CR Monitoring Report, page 1

Property: Tom and Portia and Shelburne Weiskel CR Year of this Report: 2012
Owner: name, address, phone, email if relevant (Also name of local contact if relevant.):  Portia Weiskel Address: 11 Putney Road, Leverett, MA 01054 Telephone: 413-548-9737 Email:
Date owner invited to monitoring (or reason why not): Portia was only told it would happen, but not date – we were trying to get it done between weekend railstorms.
Date and recommendations from last year's monitoring:  11/20/2011, None
Date of this year's monitoring:  10/14/2012
Participants:  Eva Gibavic, Mary Alice Wilson
Brief description of route taken (also draw on map):  See map (blue line shows path, red dots the two gps waypoints taken).  Started at the SE corner (electric box and went clockwise).
Describe any man-made alterations (include on map, add photograph or "none observed"):  None Observed
Describe any natural alterations (include on map, add photographs or "none observed"):  None observed

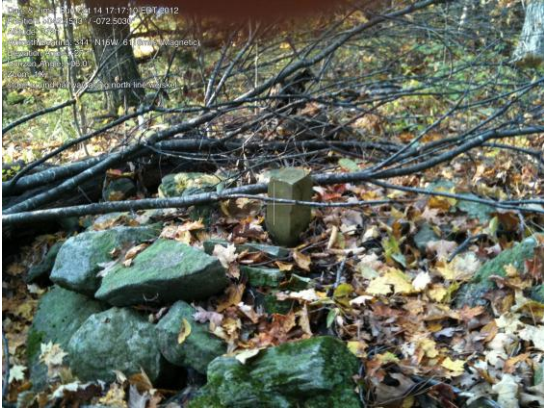
Stone bound midway along north line

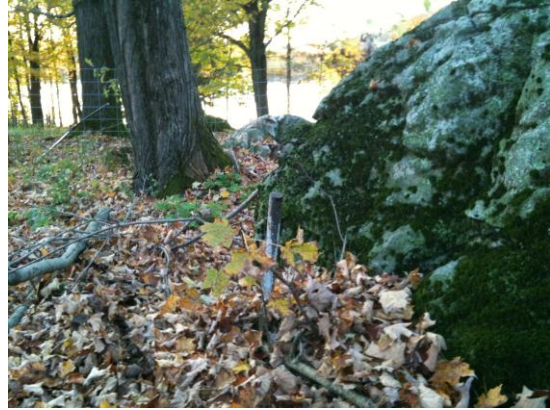
Iron pin next to fast rock (which might have drill hole), along east line.

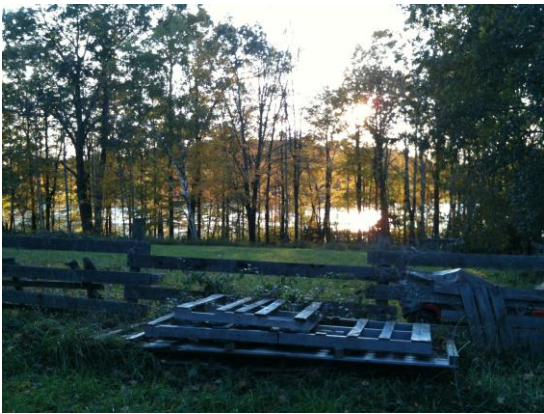
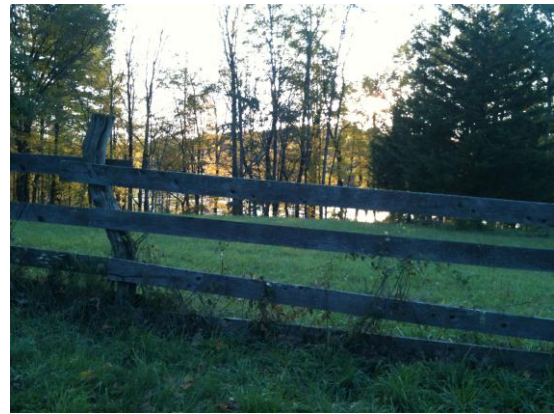
Views from east line (Putney Road) across the CR to Leverett Pond in the late afternoon light.
