Rattlesnake Gutter Trust Monitoring - CR Form

Tom and Portia and Shelburne Weiskel CR Monitoring 10/26/2013

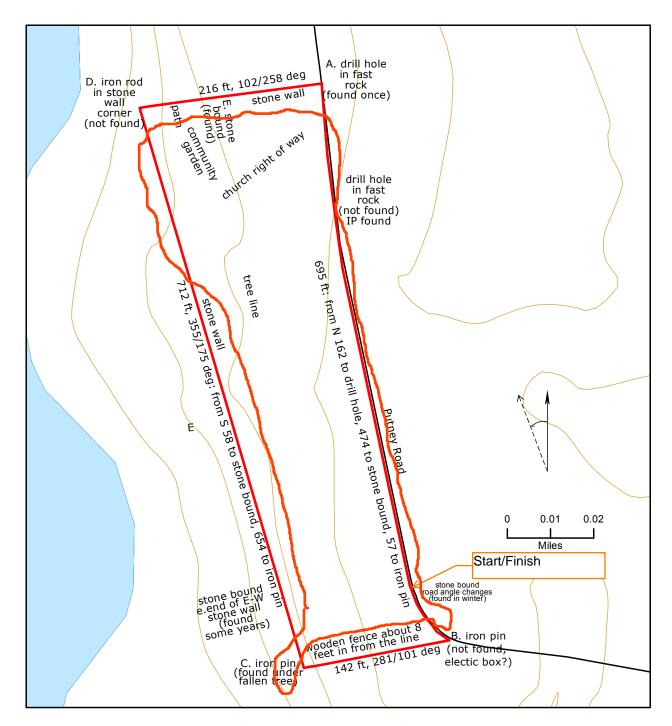
North line from west/pond end: iron pin at intersection of stone walls (not found); stone bound separating lots to north (found); drill hole in fast rock by road (found once) NE corner 42.4544, -72.5025

East line (along road): from drill hole to second drill hole in fast rock (found once, IP next to rock); to stone bound at end of straight road (found in winter, under fence line) this marks end of parcel D/beginning partial Parcel E (PB 13, p.80); to iron pin half-way along curve in road (assume electric box). SE corner 42.4526, -72.5020

South line: from electric box about 8 feet south of wooden fence to stone & iron pin (found under large fallen tree). SW corner 42.4525, -72.5026

West line/pondside church property: from iron pin to stone bound at east end of small stone wall (42.4539, -72.5032, divides parcel D from section of parcel E); continues in straight line along stone wall to northwest corner. NW corner 42.4543 ,-72.5034
