East Leverett Meadow													
Boundary and Photo Reference													
date	description	latitude	longitude	monuments	angle (degrees) from previous point	length (feet) from previous point	line marked by	other descriptors	boundary confidence?	recommendations	habitat, vegetation, geology?	photo # (ELM Boundary Lines, updated 2011)	photo date (see photo log baseline)
6/25/2011	Cushman SE corner	42.4372	-72.4860	stone, possibly damaged stone bound no post found (maple tree)	352deg	334 from middle of stream	boundary signs and red paint	trail swings on to KCR land	high	uncover marker annually	parking area, trail, pine woods	1a, 1b	1a. 9/1/2006, 2b. 6/24/2011
6/25/2011	Cushman SW corner	42.437063	-72.48673	nothing mid-stream	road edge	200	edge of road		high		parking area	2a, 2b	6/25/2011
6/25/2011	west line with Cramer to mid-stream	42.4379048	-72.487292	nothing mid-stream	344 deg	285	old electric fence posts	ends mid-stream, ip never placed	high	keep marked	pin	3a, 3b, 3c	6/24/2011

Updated June 25, 2011

ELM Boundary Lines: Updated June 25, 2011

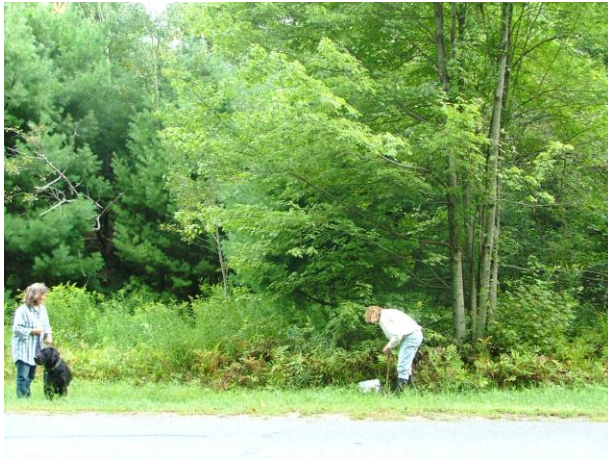
corner of Cushman Road, ELM and Kuzmeski CR 1974 King survey (Franklin County Deeds, Plan Book 39, page 40) shows "SB" (Stone Bound.) All we have found is a stone which might be the stone bound damaged by plowing. It is painted red.

1a. bending over stone, 9/1/2006

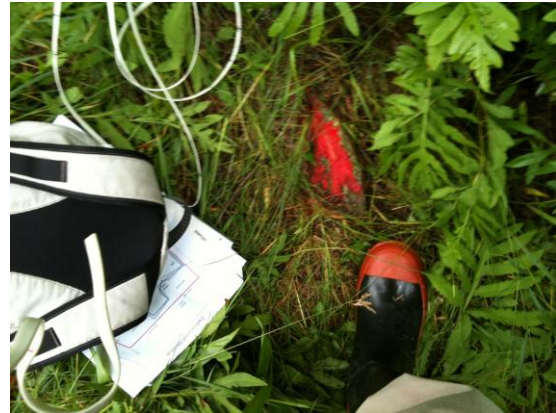
1b. painted stone, 6/24/2011

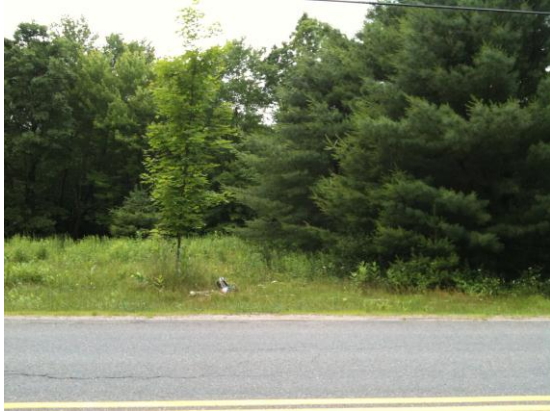
The line follows the road 200 feet to the corner with corner with Cushman Rd, ELM, and the Cramer property. The 1974 King survey shows IP which we have never found. Chet Cramer has planted a line of maples on his property. The eastern most appears to be at the corner. He also had an electric fence which matches the measurements/angle of the line to the stream so this tree could be taken as the corner. Both pictures taken 6/25/2011.

2a. Maple tree on corner looking north

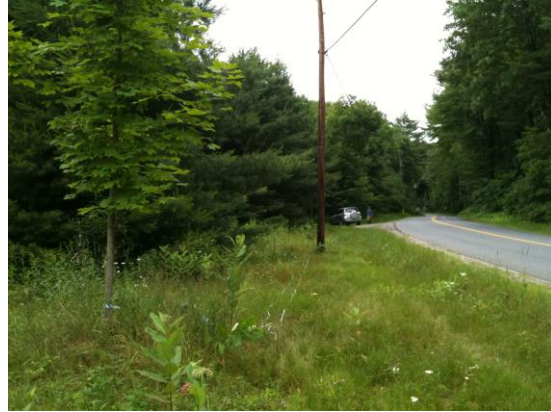
2. Same tree looking east

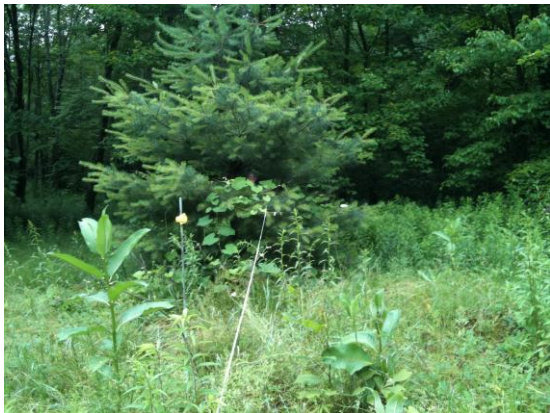
The line between Cushman Road and the middle of Roaring Brook (285 feet, 344 degrees), runs along the edge of Chet Cramer's property. He has previously had an electric fence along the first part of the line and so it is easy to follow. According to the 1974 King Survey, there never was a marker placed in the middle of the stream (no surprise). All 3 pictures taken 6/24/2011

3a. from corner maple looking north

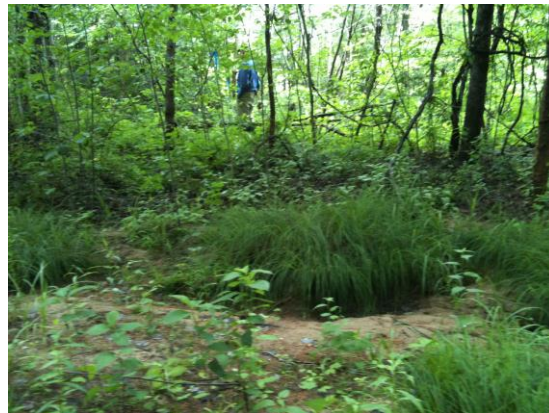
3b. on line, Bill Wilson standing by stream

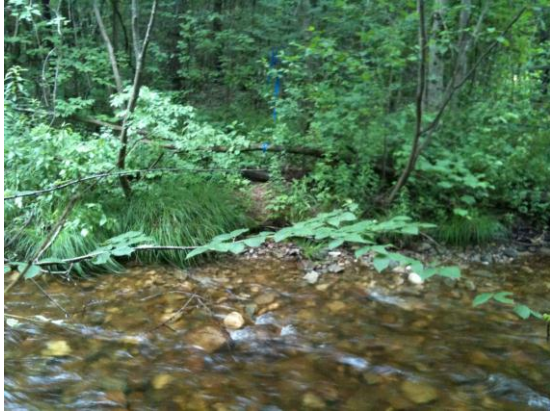
3c. Looking south to line from the north side. If line were extended north beyond the middle of the stream it would be to the west of the large Shagbark Hickory, coming out almost exactly at the 2 bluebird boxes.

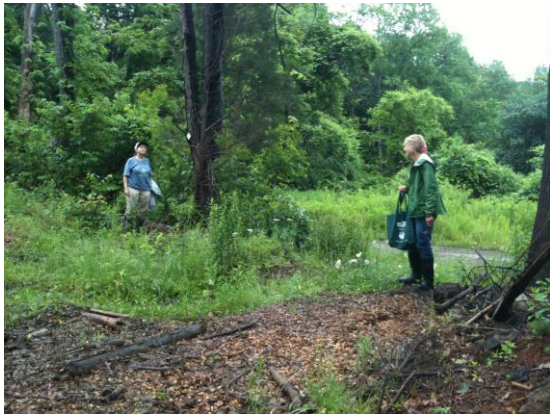
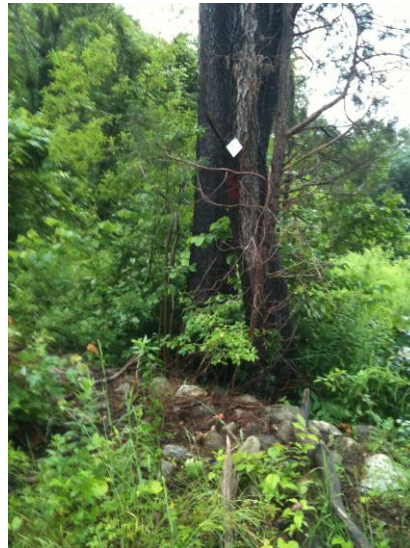
6. North boundary is along Adams property and is marked with a stone wall (1305 ft, 398 m, 106 deg.). The corner of ELM/Adams/"the tavern" is marked by a pin in the stone wall (as noted in the 1974 King survey). The woods road leading from Shutesbury Road down to the meadow is just south (inside ELM land) at this point. Recently a breach was made in the stone wall for the Adams logging. Both pictures taken 6/23/2011

6a. (above) View from Adams land
6b. (right) Stake in stone wall under tree with white RGT tag. 42.43798597, -72.48624483

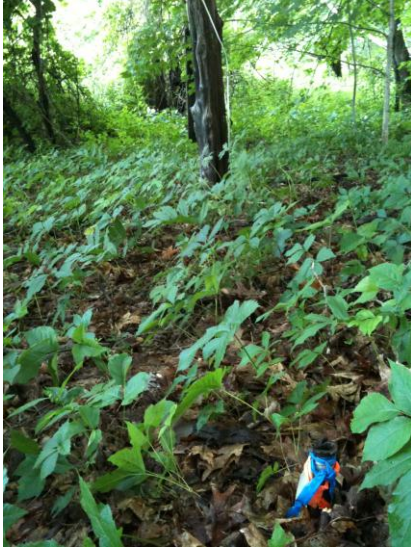
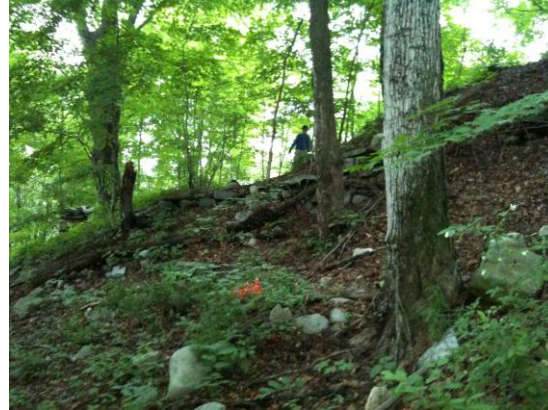
7. From ELM/Adams/tavern stone wall to corner just below tavern (487 ft, 148 m, 174 deg.). Because this area used to be kept open as a picnic area for folks living at the tavern, it is a tangle of raspberry and bittersweet. Very difficult to walk through. The line does follow an old fence line, which means mostly fence posts about to fall down. (It is easier to find this and the next corner starting in the SE corner and walking north.) The 1974 King survey shows "IP in Fence Corner" and that it exactly where it is. Both pictures were taken 6/24/2011. 42.43948549, -72.48366849

7a. (left) Iron pin protected by poison ivy
 7b. (above) Looking along line north from IP. Note scars on left sides of trees from old wire fencing. (Orange object is trash, photographer is standing on pin.)

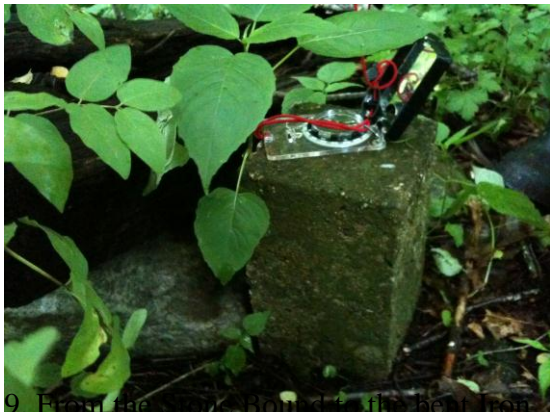
8. West jog. The eastern boundary line then jogs west bordering the Truehart property to a Stone Bound well-buried in a stand of trees and shrubs (168 ft, 51 m, 262 deg). There is no old fence line or land use change – both sides have been mowed by the Trueharts. June 24, 2011 is the first time we have found this stone bound. And then thought we had mis-measured because there was no change in land use. 42.43948038, -72.48426737

8a. Stone Bound (cement) shows on the 1974 King Survey. Another picture should be taken in the fall – one taken now would just show a wall of trees.

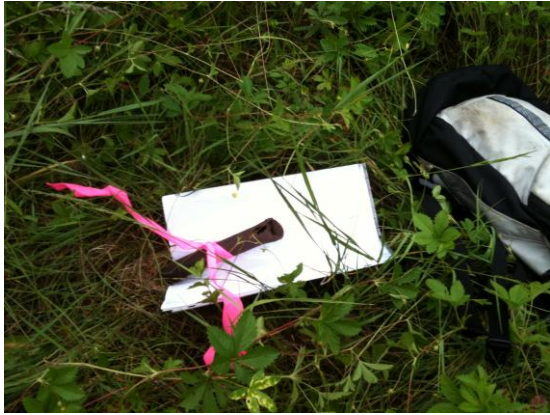
To next iron pin (212 ft, 65m, 185 deg). This final section of the eastern boundary borders the Truehart property following an old fence line - sometimes fence, often just fence posts. The iron pin had been seen briefly years ago and was found by, literally, stumbling on it while measuring the distances. It is just north of the stand of aspen. 42.43892139, -72.48411843. Both pictures taken 6/24/2011.

9a. (above) Iron Pin at ELM, Truehart, Williams/Seaman corner. (mowing is hard on pins)

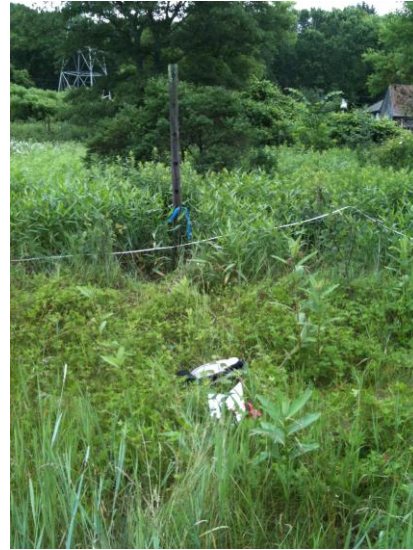
9b. (right) pin in front of backpack, looking to fence post and Truehart home. Aspen is just to the right of the photograph.

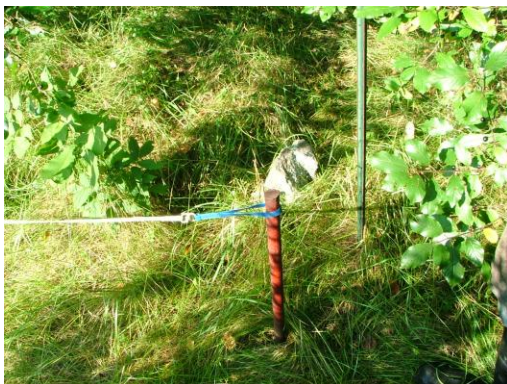
10. Southern boundary along Williams/Seaman and the Kuzmeski Conservation Restriction. The line is a straight line (93 deg). It is 395 ft, 120 m along Williams/Seaman and 257 ft, 78 m along Kuzmeski CR. (Note, this is the only part of the 1974 King survey that is no help. For this section, use a subsequent survey done for Williams and Seaman in 1997 (Franklin County Deeds, Plan Book 101, page 44). The corner between Williams/Seaman and Kuzmeski is marked by an iron post and fence post. (Not needed for the ELM property, but important for monitoring the Kuzmeski CR.)

10a. IP at corner of ELM, Williams/Seaman, Kuzmeski CR. September 7, 2006

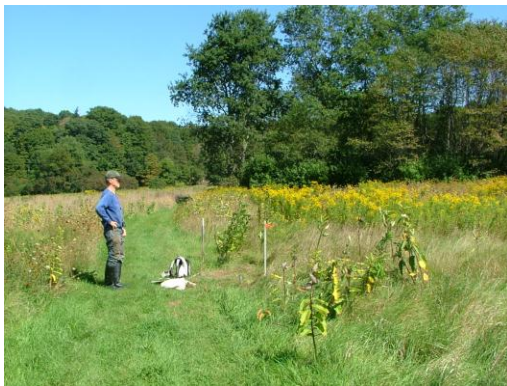
The ELM/Kuzmeski CR is at the edge of the ELM mowed field and the sometimes-mowed field closer to Roaring Brook. Both pictures taken Sept 10, 2006

10b. Looking east to white pipe marking ELM/Kuzmeski corner.

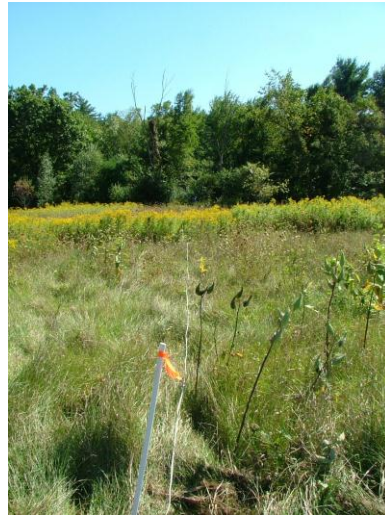
10c. Looking south from white pipe toward Roaring Brook.

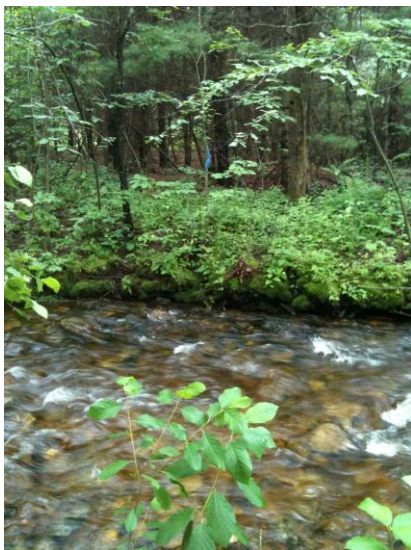
11. East Boundary Line along Kuzmeski CR. The first section of the line (see 10c above) goes through a field and then a line of trees (208 ft, 64 m, 184 deg). In the middle of the stream (no boundary marker), the angle changes (174 deg) and continues 334 ft, 102 m to Cushman Road and the painted stone (see #1). It is this second section that is hard to follow because there is not land use change, in fact the trail into the meadow goes on to the CR. All 3 pictures taken 6/24/2011.

11a. View from the north side of Roaring Brook looking south to the flag/line. The Americorps Bridge is out of view to the right (downstream).

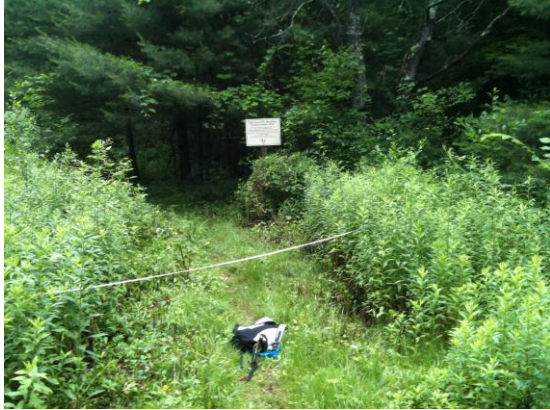
11b. ELM/Kuzmeski line (white tape) as it crosses the trail just east of the large ELM sign.

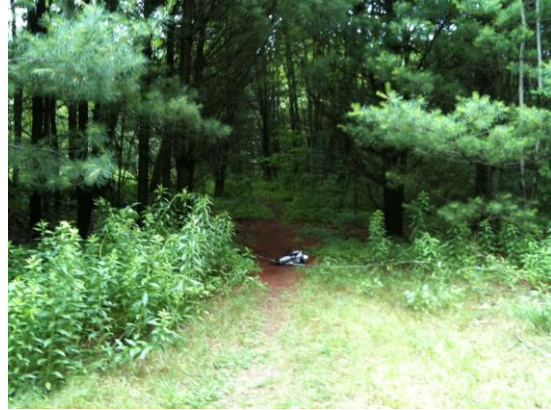
11c. ELM/Kuzmeski line (white tape and backpack) as it crosses the trail just north of the parking area.
