Property: Gibavic Family Conservation Restriction	Year of this Report: 2013
Owner: name, address, phone, email if relevant (Also name of local contact if relevant.): ( <i>skip if owned</i> ) Eva Gibavic, 10 Rattlesnake Gutter Rd, Leverett, MA 01054, 413- 548-9451 Donald Gibavic, 20 Cave Hill Road, Leverett, MA, 01054, 413-548-9322 Anne Gibavic, PO Box 74, Sutton, VT 05867 Paul Gibavic, 3 Sunderland Rd, Montague, MA 01351	
Date owner invited to monitoring ( <i>skip if owned</i> ) August 2, 2013	
Date and recommendations from last year's monitoring: 1. Paint the lines. 2. Follow-up on the vernal pool certification. 3. Try to figure out NW corner 4. After dry weather, motorcycle should be removed	
Date of this year's monitoring: August 2, 2013 (Mary Alice returned to north line on August 28)	
Participants: Mary Alice Wilson (RGT); Eva Gibavic (Gibavic Family)	
Brief description of route taken (also draw on map):  Counter clockwise from Eva's house. We did not visit the SW corner and walked in the meadow rather than along the very full stream.

Photographs of NW corner

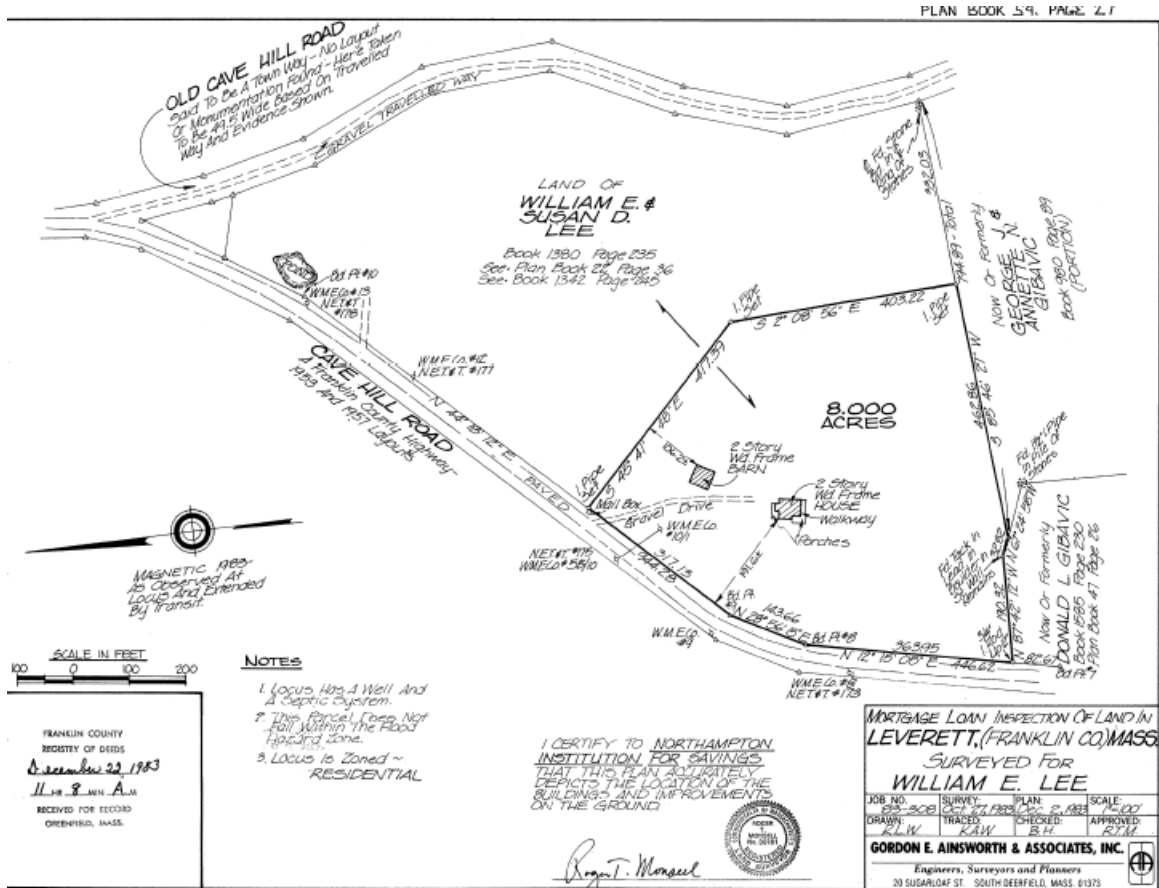
Survey does not include the iron pipe which is on the north line fairly near the iron pipe labeled "D" on the monitoring map. Nor does it mention the drill hole. The lead pin in the boulder in the stone wall was not found, but that stone wall is 32 feet from the drill hole (see photographs).

Northwest corner, drill hole  
(from baseline report)

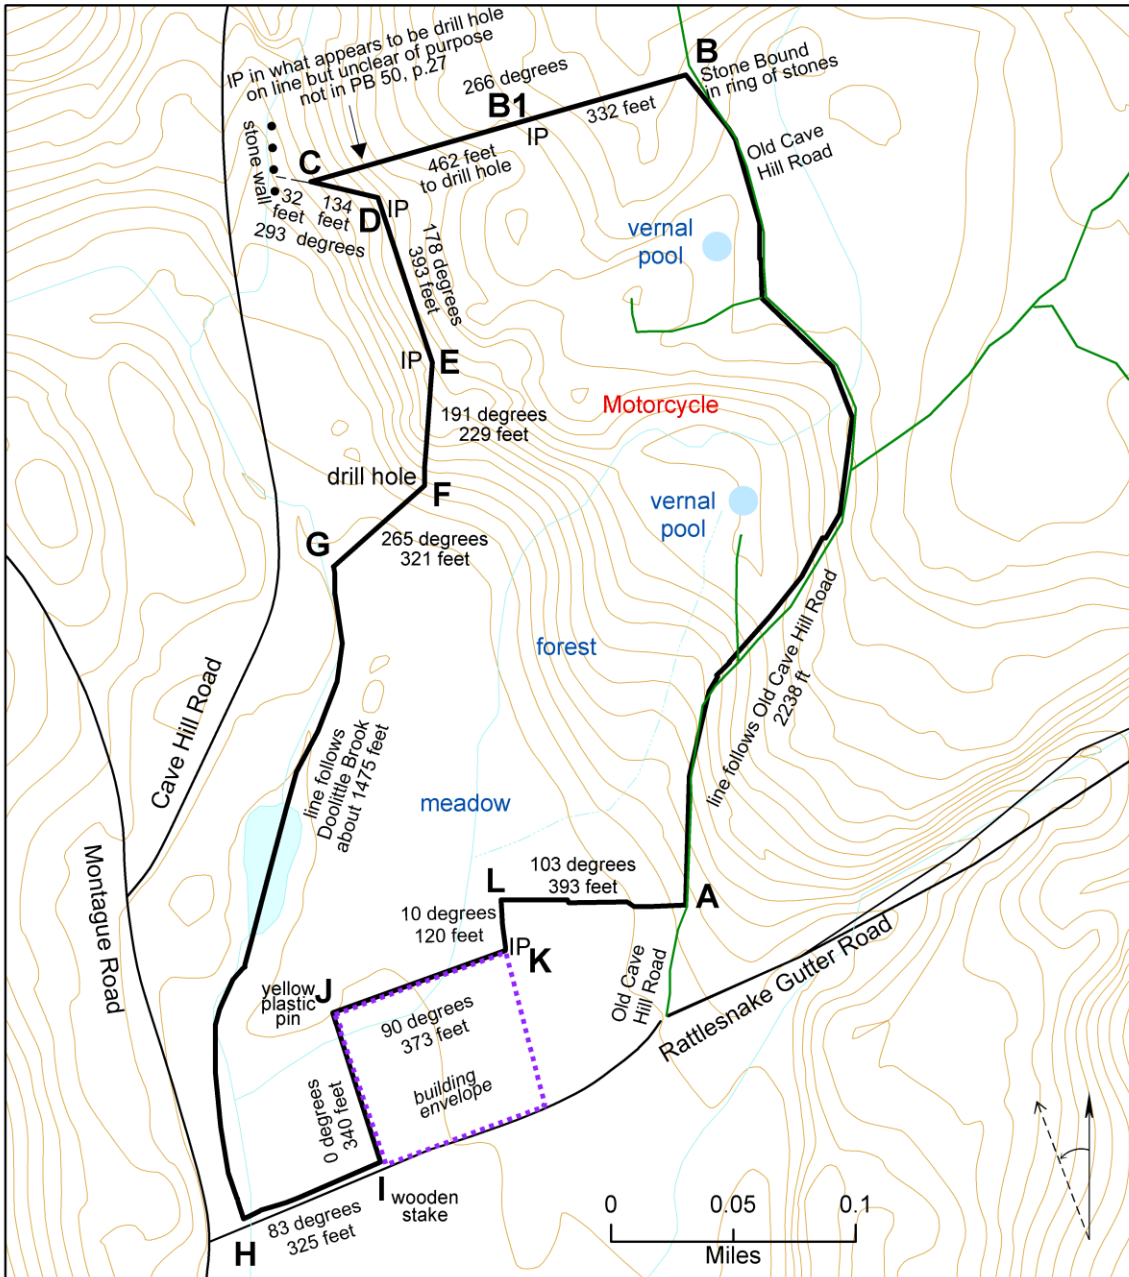
# Gibavic Family CR for Montoring

- A. SE corner with Eva Beth Gibavic (survey), 42.47937, -72.49482 (no pin found)
- B. E line Old Cave Hill and Old Whitney Roads to stone marker, 42.48442, -72.49471

- B1. IP along line, 42.484091, -72.496111 (corner post for lots to north)
- C. drill hole on cliff/jumble of rocks, 42.483688, -72.497845. If one were to extend line from C to D to the nw 32 feet, that line would come to stone wall with "lead in boulder" (PB 59, p. 27)

- J. Inside corner of building envelope in meadow. Yellow pin found occasionally, 42.47882, -72.49757
- K. Corner in stone wall, iron pin to right of white quartz rock, 42.47904, -72.49635
