Property: Gibavic Family Conservation Restriction Year of this Report: 2012
Owner: name, address, phone, email if relevant (Also name of local contact if relevant.): Eva Gibavic, 10 Rattlesnake Gutter Rd, Leverett, MA 01054, 413- 548-9451 Donald Gibavic, 20 Cave Hill Road, Leverett, MA, 01054, 413-548-9322 Ann Gibavic, PO Box 74, Sutton, VT 05867 Paul Gibavic, 3 Sunderland Rd, Montague, MA 01351
Date owner invited to monitoring (<i>skip if owned</i>) Monitoring was planned so that Eva Gibavic could participate.
Date and recommendations from last year's monitoring: 11/20/2011 1. paint fading boundaries 2. review pins/corners (C-F) in NW area, confirm gps readings and correct map 3. look for stone wall corner pin (I) 4. look for illusive "meadow pin" (J)
Date of this year's monitoring: October 14, 2012
Participants: Mary Alice Wilson (for RGT), Eva Gibavic (for Gibavic family)
Brief description of route taken (also draw on map): See green track on map. We went counterclockwise from Eva's land to Old Cave Hill Road. Red circles are location of waypoints taken to confirm readings taken last year (B1, C, D, E, F) or to confirm readings from previous years. (I, J) Changes were made in th

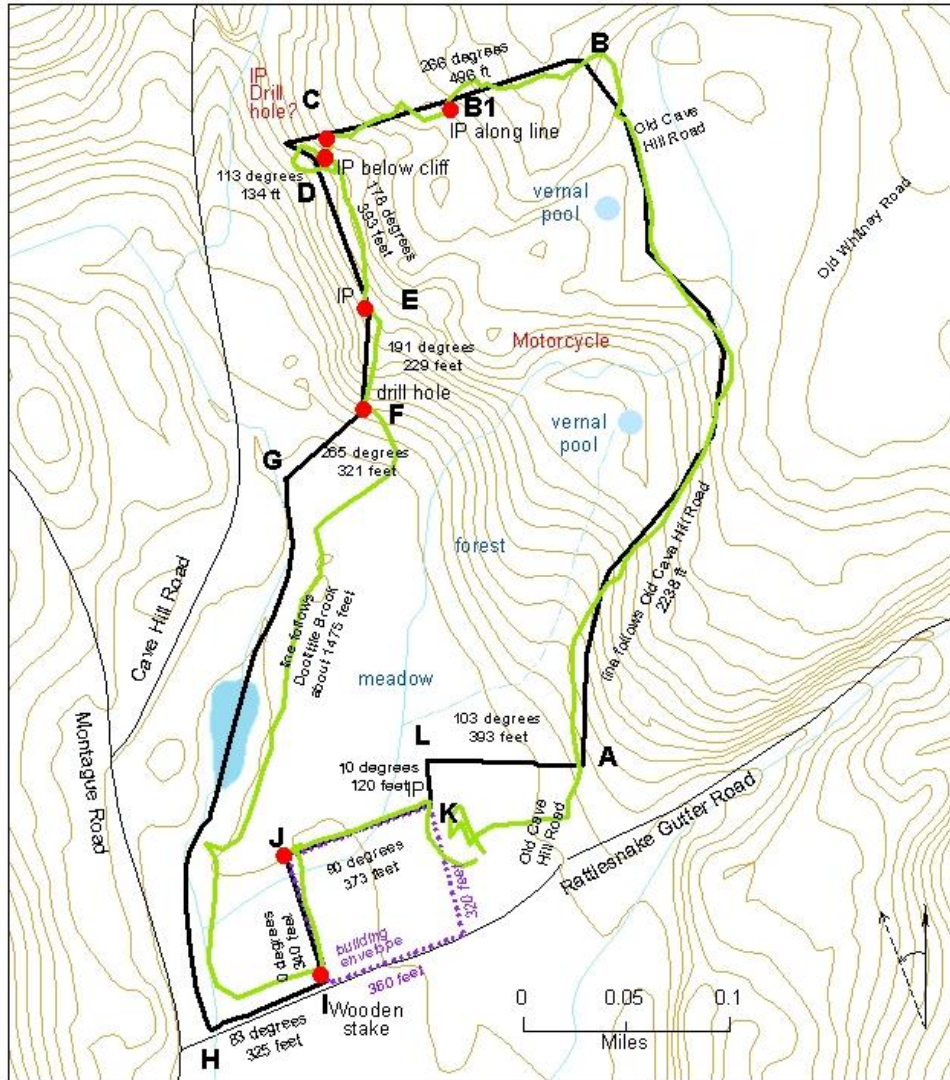
Gibavic CR for Montoring - green track, red gps points, Oct 14, 2012
 (Note: Some line correction on west and south. Still unsure NW corner)

- A SE corner with Eva Beth Gibavic (survey), 42.47937, -72.49482 (no pin found)
- B. E line Old Cave Hill and Old Whitney Roads to stone marker, 42.48442, -72.49471

- B1. IP along line, 42.483997, -72.49091
- C. N lines with Melcuk + Kingston (surveys) to corner at W end of cliff, 42.483997, -72.496091 ip (drill hole?)

- J. Inside corner of building envelope in meadow. Yellow pin found occasionally, 42.47882, -72.49757
- K. Corner in stone wall, iron pin to right of white quartz rock, 42.47904, -72.49635
