RGT CR Monitoring Report, page 1

Property: Tom and Portia and Shelburne Weiskel CR Year of this Report: 2012
Owner: name, address, phone, email if relevant (Also name of local contact if relevant.):  Portia Weiskel Address: 11 Putney Road, Leverett, MA 01054 Telephone: 413-548-9737 Email:
Date owner invited to monitoring (or reason why not): Portia was only told it would happen, but not date – we were trying to get it done between weekend railstorms.
Date and recommendations from last year's monitoring:  11/20/2011, None
Date of this year's monitoring:  10/14/2012
Participants:  Eva Gibavic, Mary Alice Wilson
Brief description of route taken (also draw on map):  See map (blue line shows path, red dots the two gps waypoints taken).  Started at the SE corner (electric box and went clockwise).
Describe any man-made alterations (include on map, add photograph or "none observed"):  None Observed
Describe any natural alterations (include on map, add photographs or "none observed"):  None observed

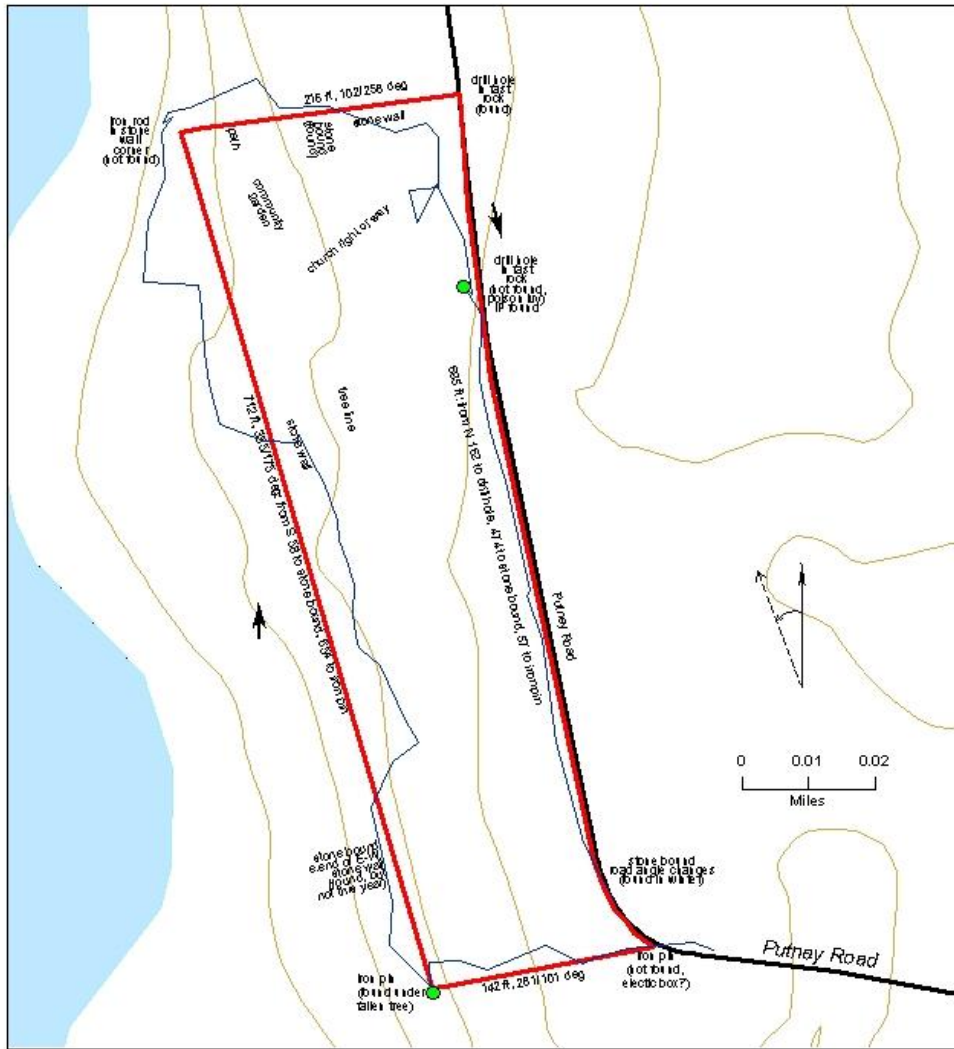
**Tom and Portia and Shelburne Weiskel CR for Monitoring**

north line from west/pond end: iron pin at intersection of stone walls (not found); stone bound separating lots to north (found); drill hole in fast rock by road (found) NE corner 42.454019, -72.502556

east line (along road): from drill hole to second drill hole in fast rock (found once) but also IP (42.452467, -72.5026190; to stone bound at end of straight road (found in winter, under fence line) this marks end of parcel D/beginning partial Parcel E (PB 13, p.80); to iron pin half-way along curve in road (assume electric wires box). SE corner 42.4526, -72.5020 (new gps reading, slight change made in line as well)

south line: from electric box just south of wooden fence to stone iron pin (found under large fallen tree). SW corner 42.4525, -72.5026
